Real-time bird detection and collision risk control in wind farms

Martin Georgiev, Pavel Zehtindjiev

Institute of Biodiversity and Ecosystem Research Bulgarian Academy of Sciences

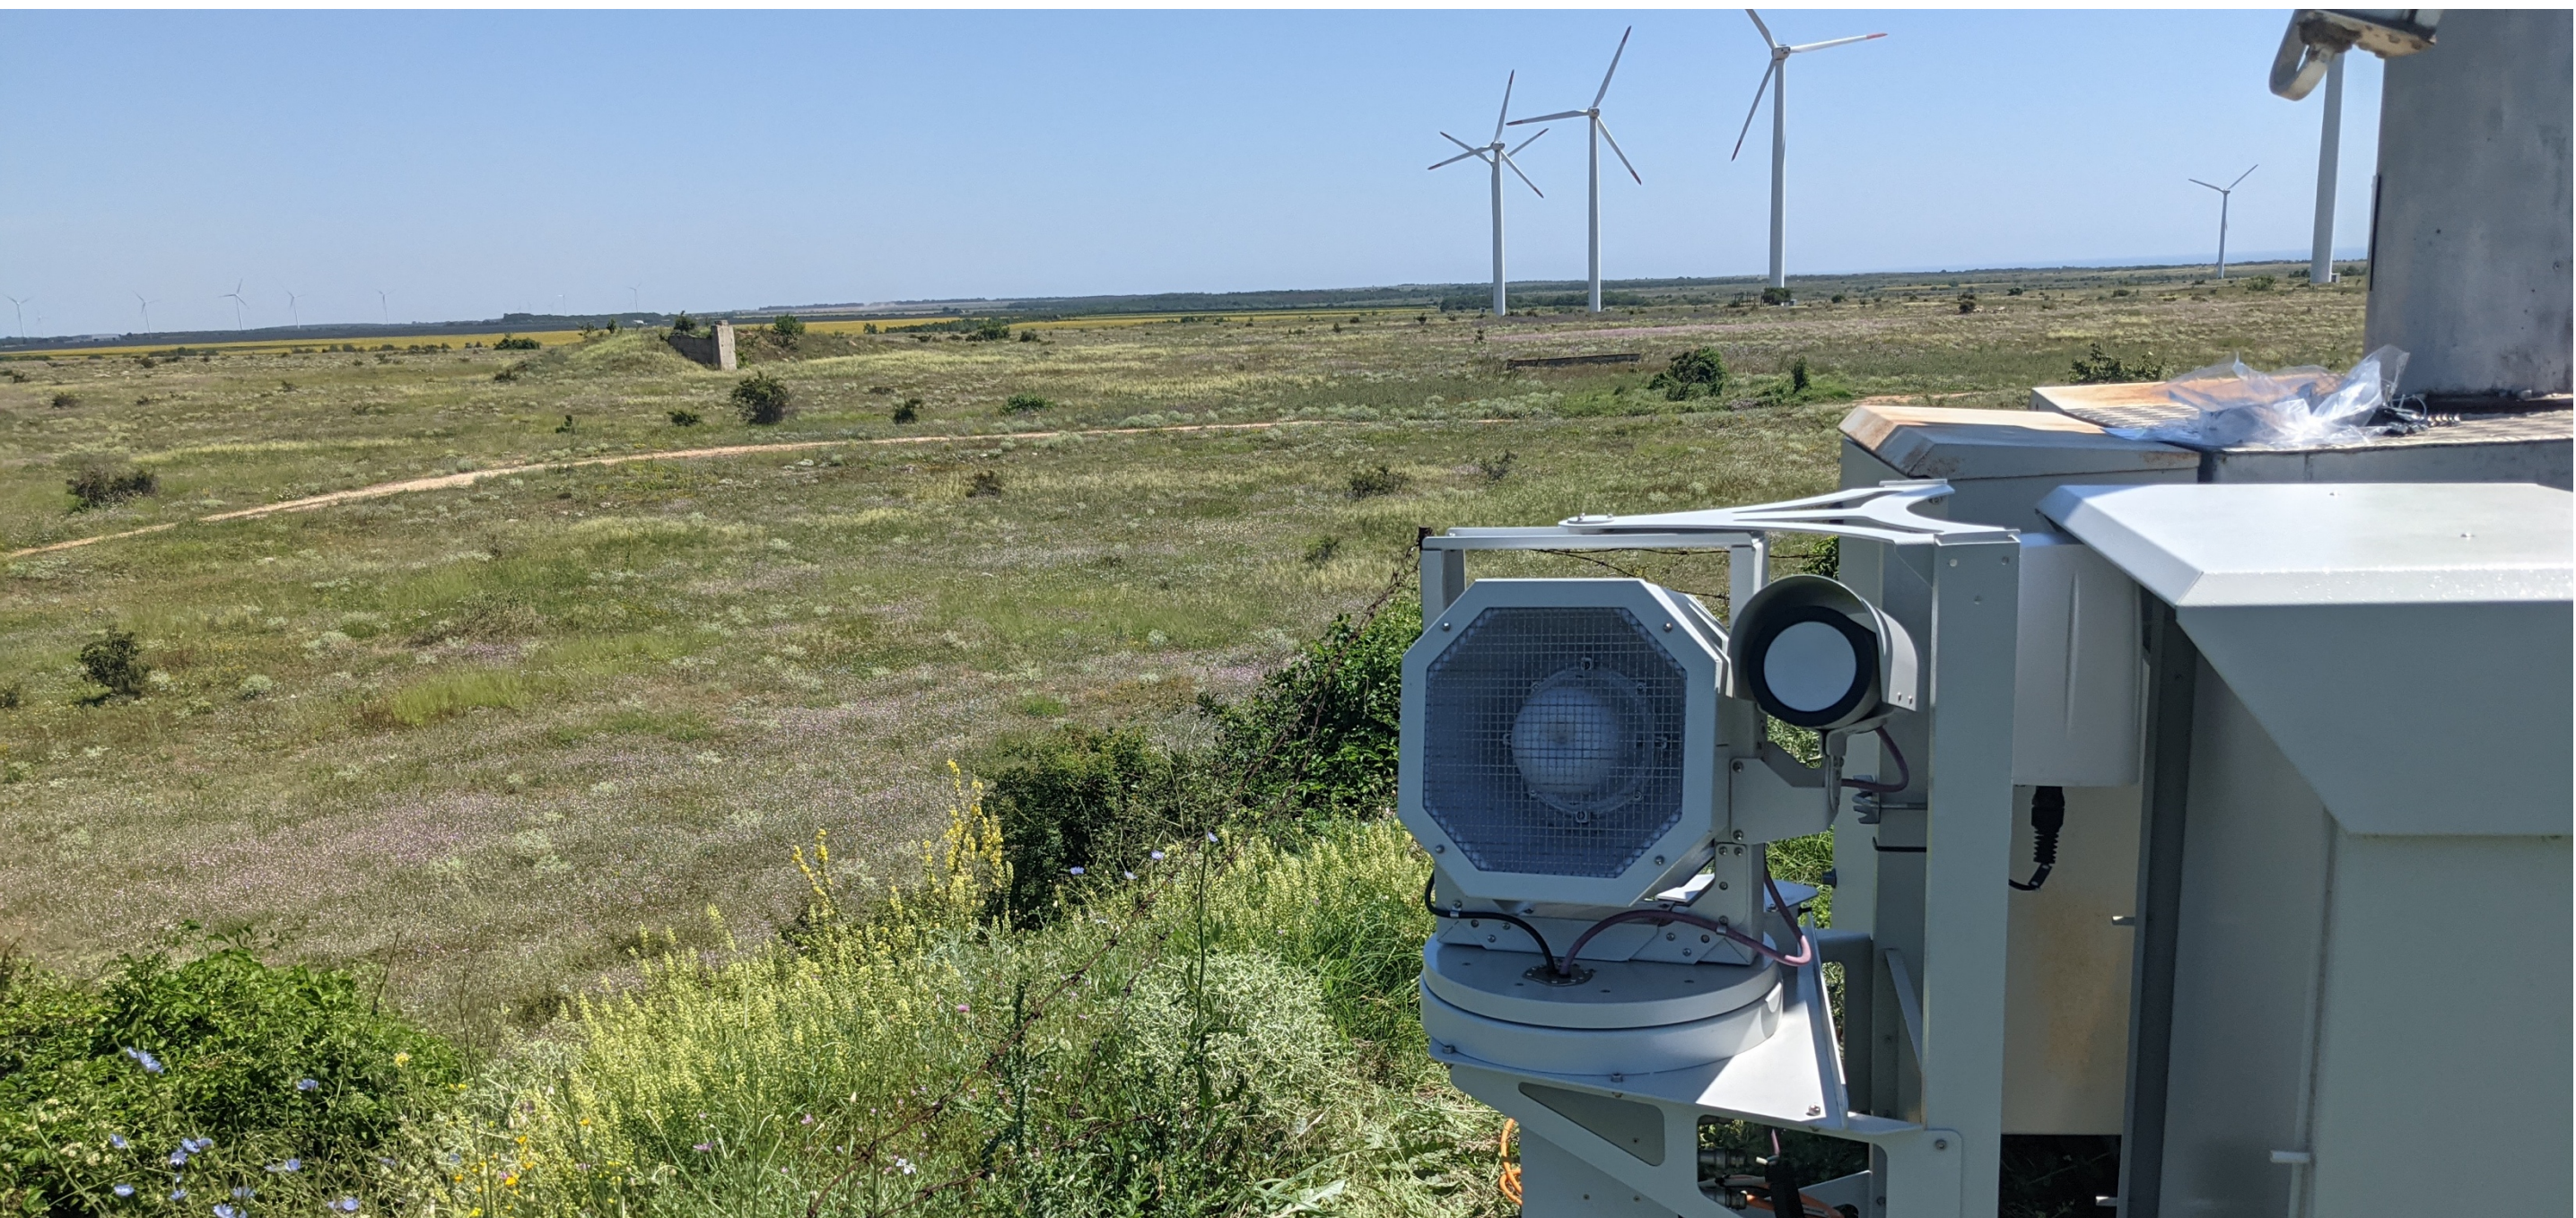
Figure 1. Volacom's BCAS, installed in the Kaliakra region, NE Bulgaria.

We analyzed the detection rate efficiency of a ground-mounted bird collision avoidance system, based on thermal imaging with the following technical specifications.

- Vertical field of view: **26 °**
- Horizontal field of view per frame: **32 °**
- Total horizontal field of view: **192 °**

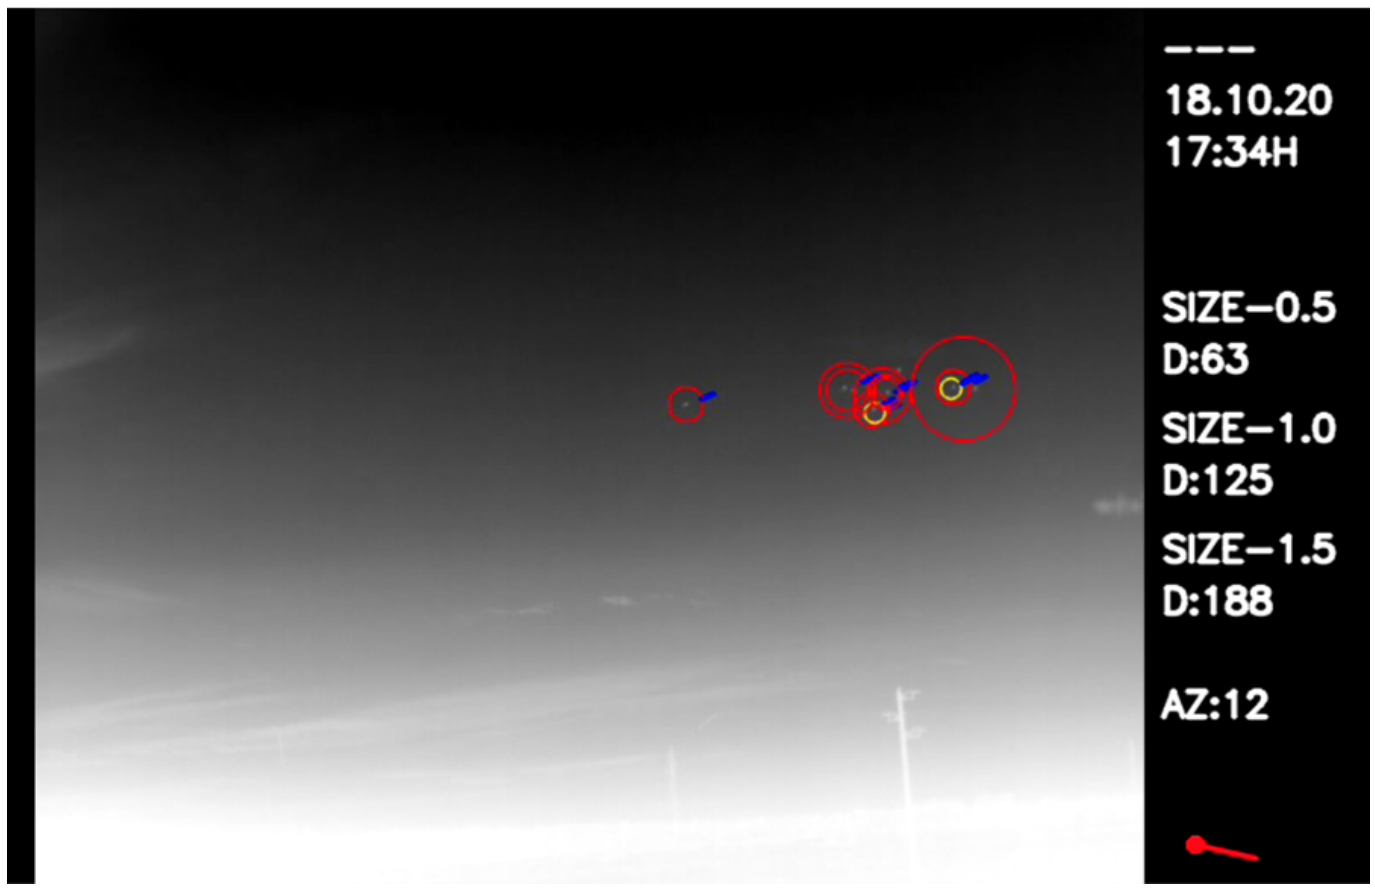
Figure 2. Bird detections as seen by the Volacom thermal software user interface.

The experiment was carried out at an operating wind turbine park in NE Bulgaria during the months of August and October 2020, within the period of autumn bird migration. The system was equipped with a custom-built detection software providing live picture and video logs of each recorded detection. After the end of the experiment the video recordings were analyzed individually in order to assess the validity of each detection.

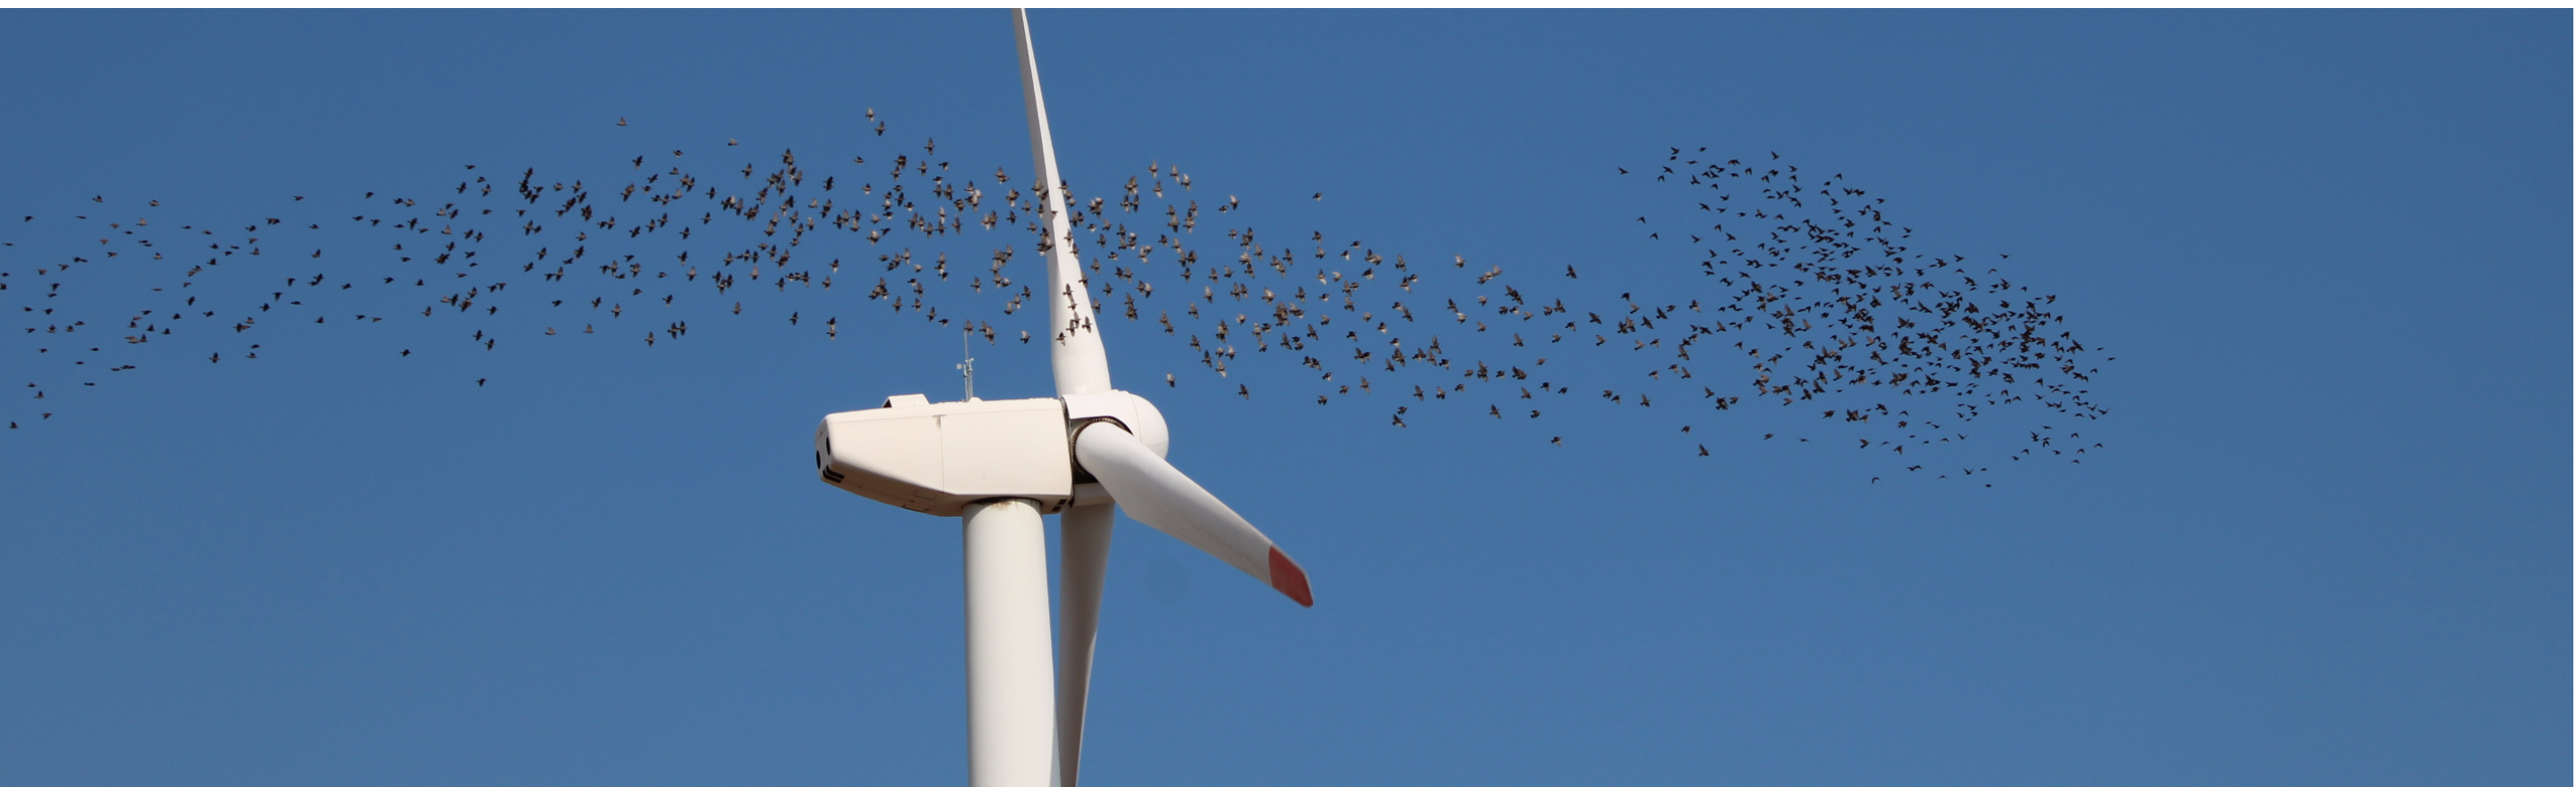
Figure 5. A flock of European starling (*Sturnus vulgaris*) passing a wind turbine generator with no bird deterrence systems installed.
